## Moving Rivers & Creeks

## What Happened To The Fish Creek Pathway?

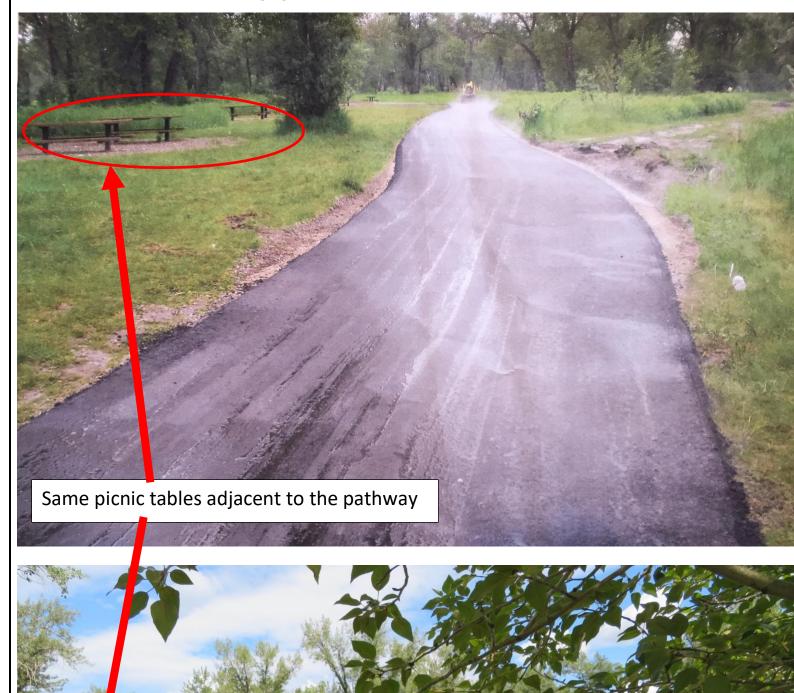
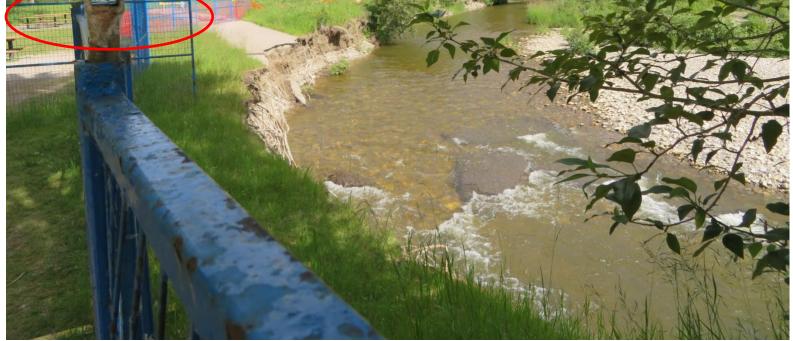
**Top picture:** Fish Creek Pathway north of Hull's Wood parking lot in 2011 - after being rebuilt due to being washed away in the 2005 flood (Fish Creek is out of frame to the north, on the right). Bottom picture: Fish Creek Pathway in

July 2020 –

after being washed away in June 2020 by high water from several heavy rainstorms. Creek has moved south.

- Natural movement: creeks and rivers naturally move (meander) within their floodplain over time, especially during times of high water; branches, trees, and rocks are carried downstream during high flows and can block a creek or river channel, so the creek or river creates a new path. Creeks and rivers can also be blocked by ice dams, especially in springtime.

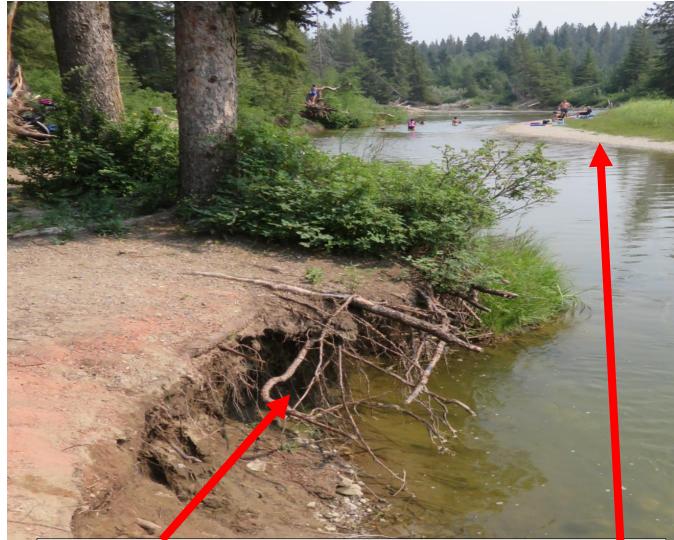
Fish Creek has cut into the bank on the outer bend (with fastermoving water), creating a cliff-like "cutbank", on the north side of the creek at Bebo Grove. Downstream, on the inner bend (where there is slower-moving water), the creek is depositing gravel and sediment, creating a "point bar" or sand bar. This point bar area that the creek has moved away from is now being re-vegetated by willows and balsam poplar.

"Cutbank" created on outer bend, "Point Bar" created on inner bend
